CASE STUDY

WATER WELL SERVICES

VILLAGE OF ROMEIOVILLE, IL

Developing and implementing a long-lasting, multi-tier innovative solution to solve on-going sanding conditions plaguing a deep water well.

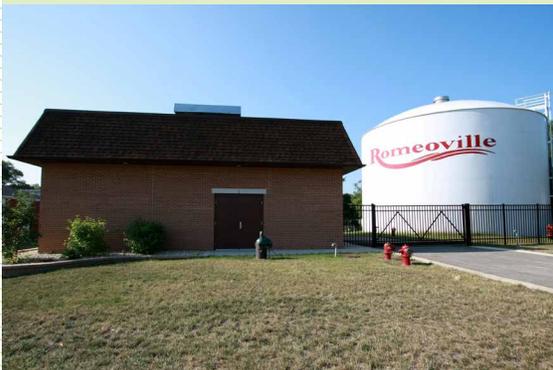
"A Custom-engineered solution including a new Centrilift pump, along with 255ft. of Aquastream® sand separator and a custom fabricated stainless steel motor successfully eliminated sanding conditions"

An abrasion resistant Centrilift pump with a Ni-Resist package was installed and coupled with an Aquastream® sand separator for added protection. The Centrilift pump, constructed of Nickel Aluminum Bronze, is designed to operate in harsh sanding conditions. For better results, the pump was upgraded to premium construction with the Abrasion Resistance technology Ni-Resist that includes tungsten carbide bearings and sleeves between every stage, or a 1:1 ratio. This is one of the hardest metallurgies known and protects the hub of the stage from being attacked by the sand. Tests show an 8X increase in run life with this protection alone in sand producing wells. Once the pump was installed, flow tests conducted upon startup showed that very little to no sand was present in Well No 11. The pump is also producing significantly better than anticipated.

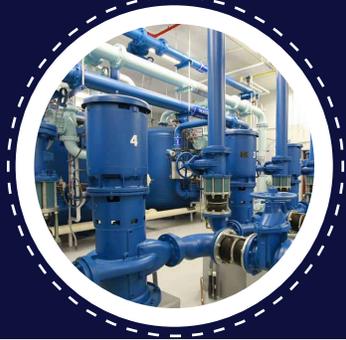
Once the pumping equipment was pulled, Water Well Solutions conducted an investigational downhole television survey of Well No 11. The TV survey revealed that the well had been previously blasted with bulk blasts of dynamite and that sand was flowing into the well at 1426 ft. Blasting can defragment sandstone causing it to become unstable which leads to sanding conditions which can continue to plague the well for years. The Byron Jackson bowl assembly of Well No. 11 was also disassembled and inspected. It showed significant amount of wear in the rotating assembly most likely from sand wear. The wear rings installed in the bowl assembly during the previous service, were almost completely worn away. In addition, due to wear characteristics, it was apparent that there would have been significant vibration in the bowl assembly which likely would have been transmitted to the motor.

Several approaches were then discussed in collaboration with the Village water operators to prolong the lifespan of the pumping equipment. While pumping with a 300Hp pumping equipment, the sanding condition generally occurred only upon startup when higher entrance velocities were created in the well. Therefore, the solution that looked most promising and was agreed upon was to downsize the pumping equipment and increase the run time. Downsizing the

pumping equipment from 800gpm to 700gpm reduced the likelihood of high entrance velocities and turbulent flows to occur upon startup. Downsizing the well production also reduced the likelihood of sand being pulled in, as experienced with higher flow rates. Once the flow rate stabilized, the sanding condition decreased proportionally as entrance velocities decreased. Well No 11 has experienced a significant reduction in sand pumping while pumping consistently at a flow rate of ~700gpm.

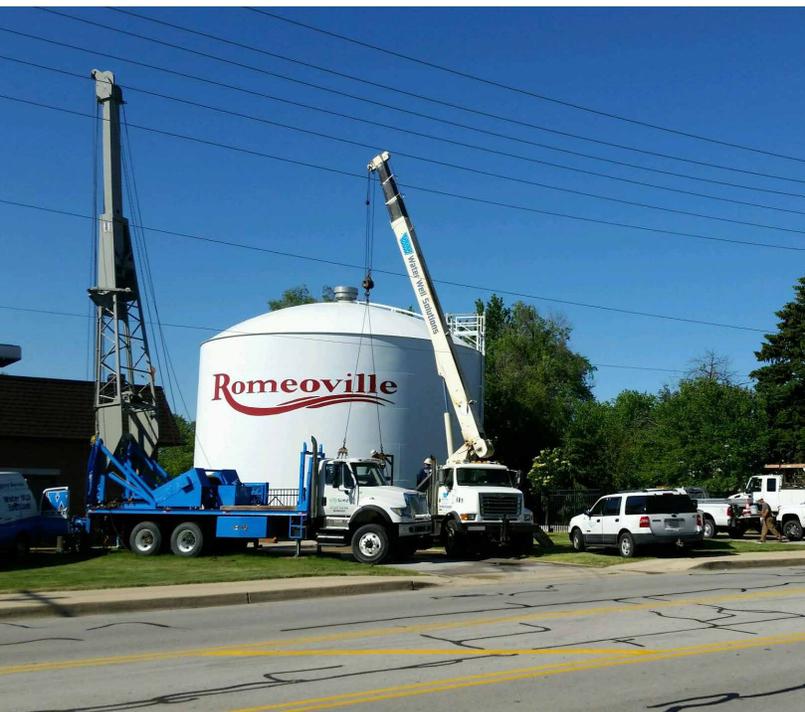
During the repairs to Well No. 11, Water Well Solutions field technicians also took an in-depth look at the pipe threads. The inspection involved cleaning the pipe threads of grease and debris to view the condition of the threads. The pipe sections were not in terrible shape but a lot of erosion was discovered and subsequently addressed in the middle of the threads where there is no thread engagement. A final chemical rehabilitation of Well No 11 was performed before placing it back into service on June 2017. The well is currently producing 700gpm at an 858ft. pumping level.
